# Oil Exudation and Impaired Stress Relaxation: Unintended Consequences of Gel Formation in Excessively Modified Asphalt Binders

Aidan Woods, Jianmin Ma, Chanaka Nawarathna and  
Simon A.M. Hesp

Queen's University, Kingston, Ontario

NESMEA, Harrisburg, Pennsylvania, USA  
October 28-29, 2025

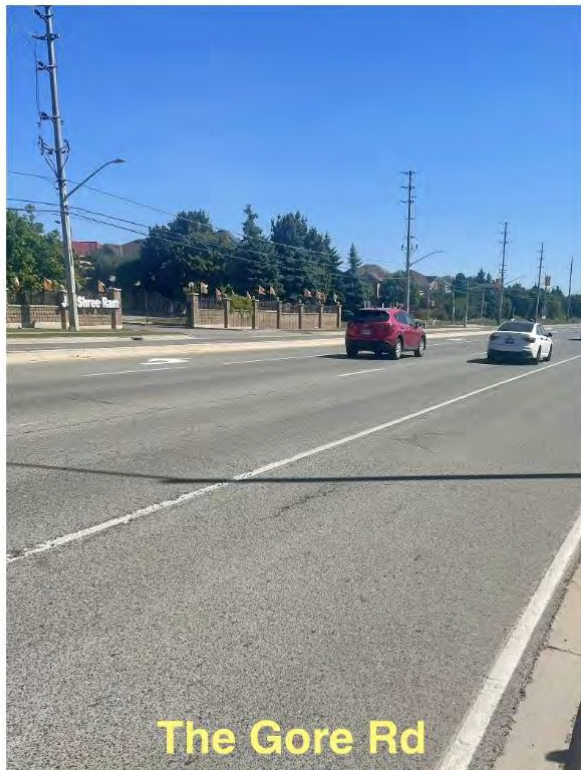
2002

23 Years of Age  
Early Superpave  
AC @ \$300/tonne

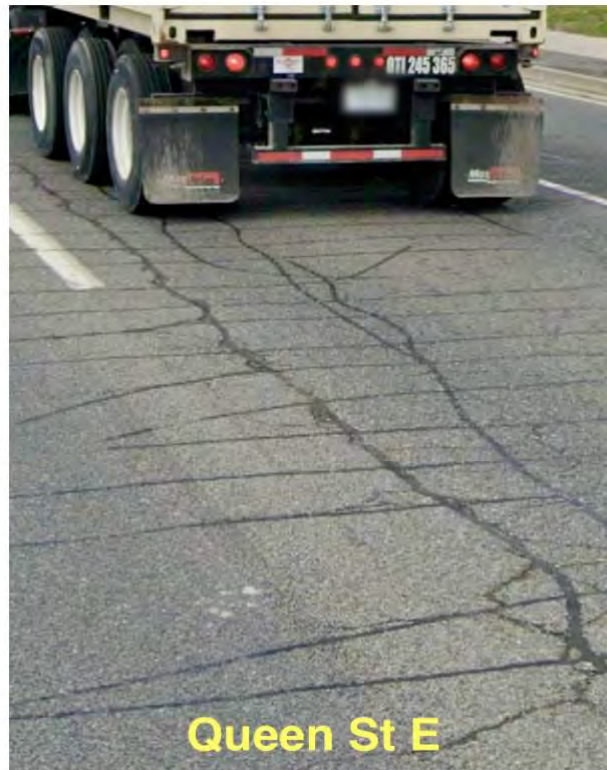
2010

15 Years of Age  
Established Superpave  
AC @ \$900/tonne

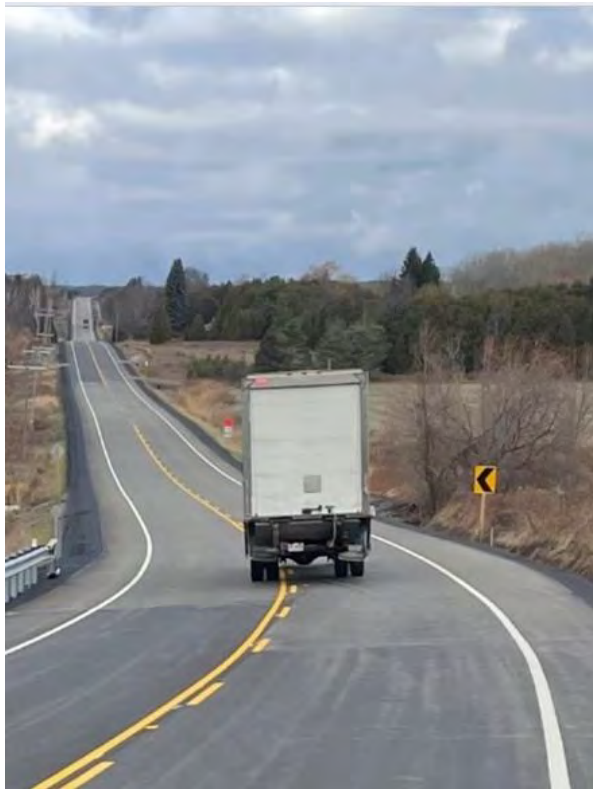
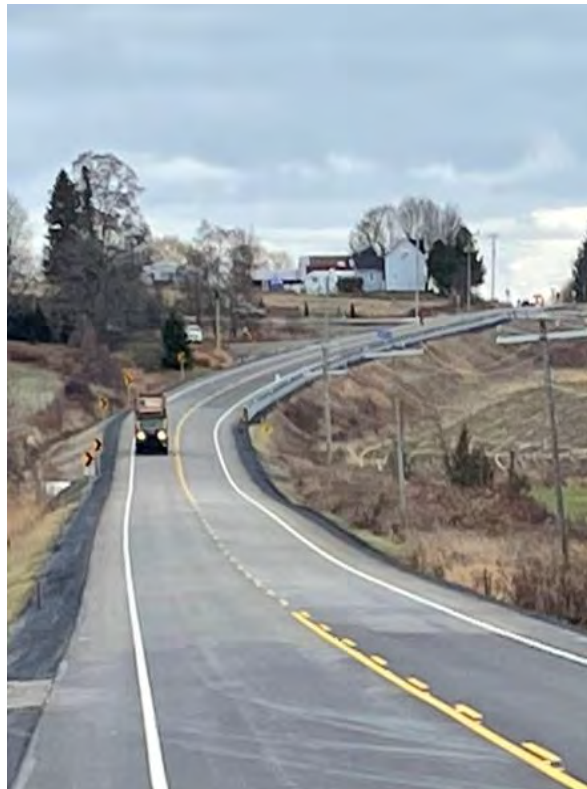
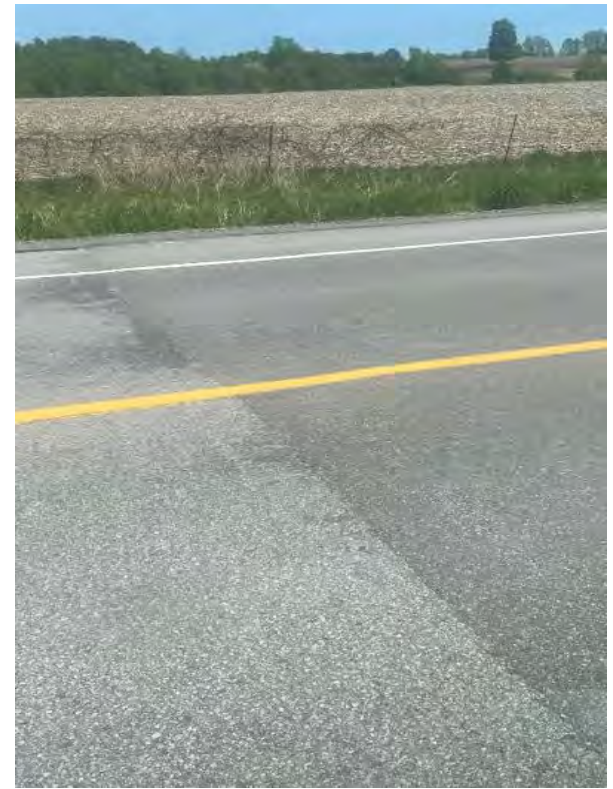
# Durham Region Early Stripping (2022)

- Newtonville Road (RR 18) pavement trial.
- Constructed late 2022 and binder stripped before winter.
- Binder was over modified (PG 64-34 versus PG 58-34).
- High natural sand mix.

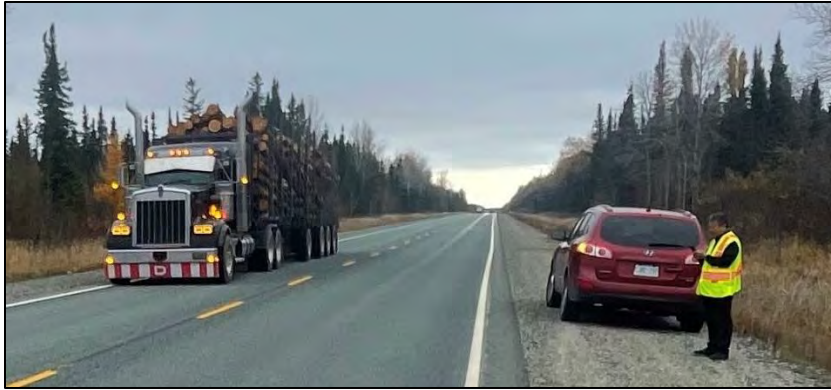
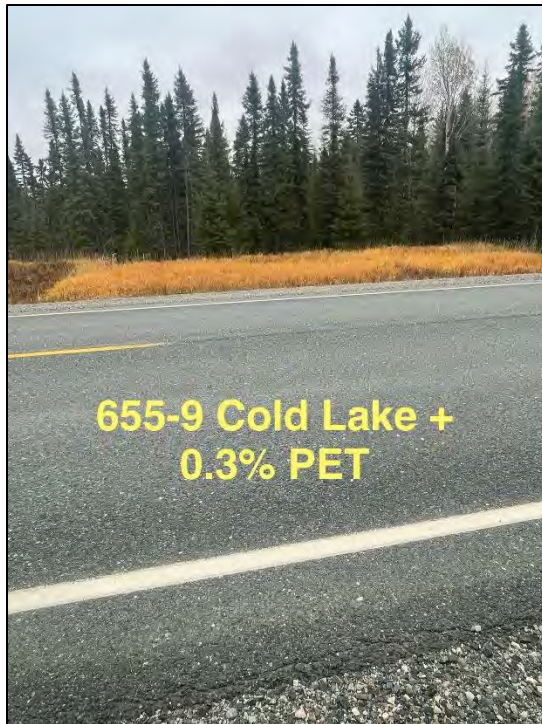
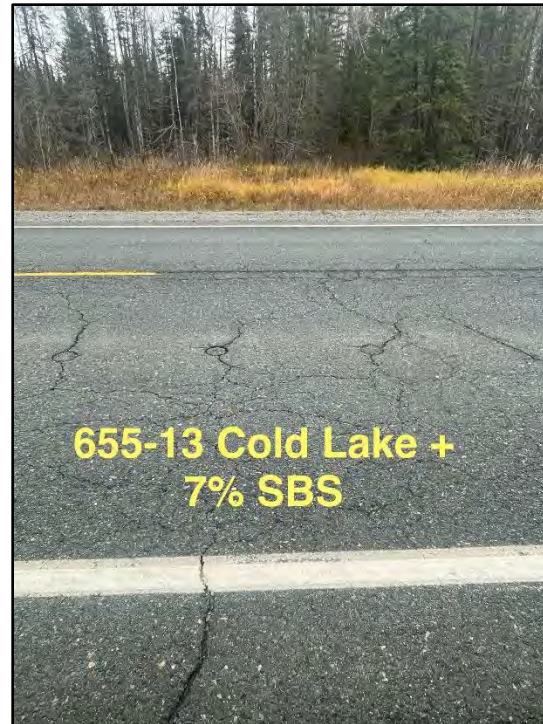
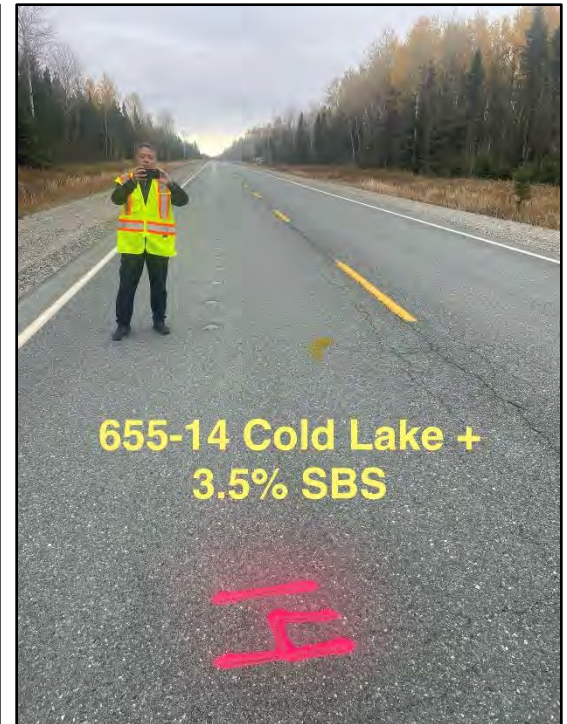
# Highway 655 Cold Lake Trial (2007-2024)

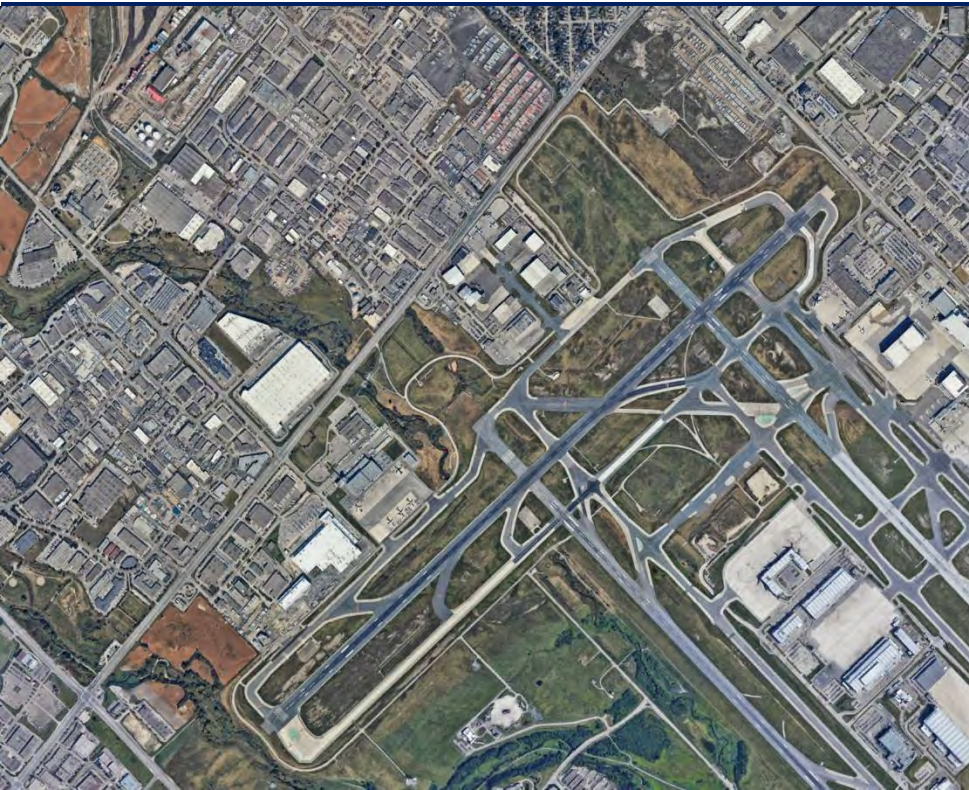
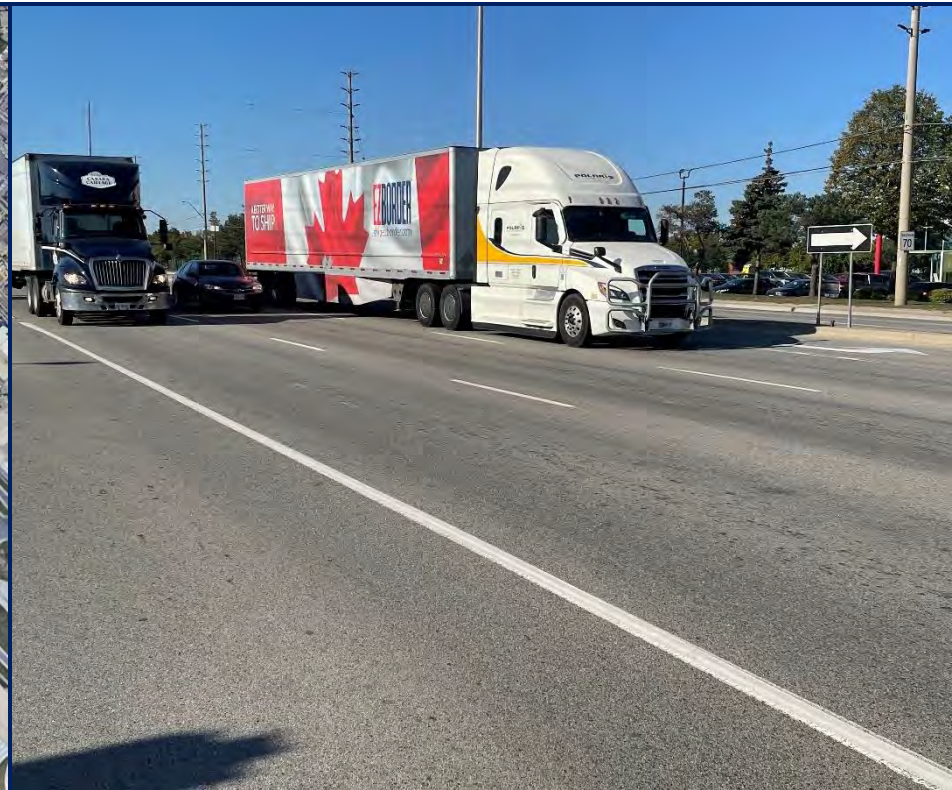
# Derry Road East, Peel Region, Ontario

- Total reconstruction in 2015.
- 0 cracks/2,800 m @ 6 lanes in 2025.
- One of Canada's busiest municipal truck routes.
- Recovered grade spans ranged from 97.6-108.6 Celsius.
